## Item #12893584 - 2023 Kenworth T680 6x4 T/A Sleeper Truck Tractor

# Inspection Report

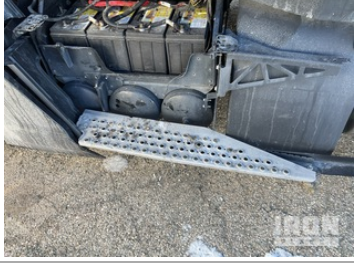
| Steps/Ladders | Missing components | |

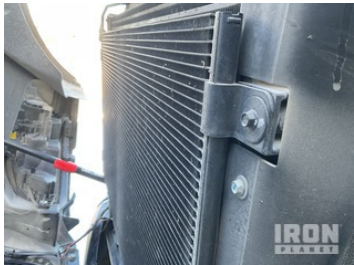
| Radiator | ★★★★☆ | |

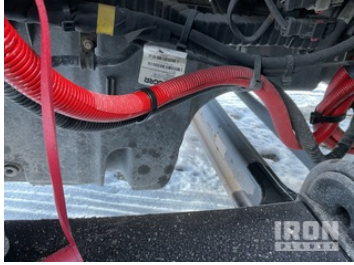
| Oil Leaks | No dripping leaks | |

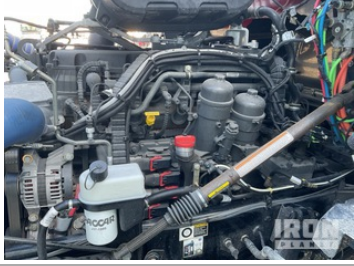
| Fuel Leaks | No dripping leaks | |

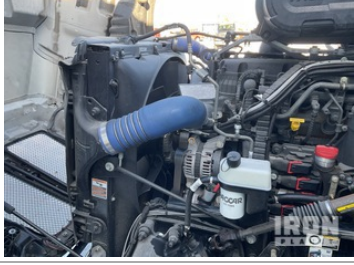
| Cooling System Leaks | No dripping leaks | |

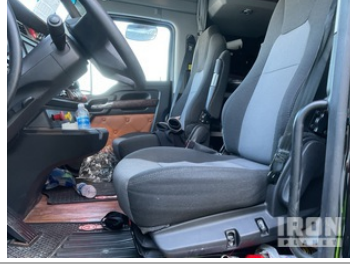
| Item | Assessment | Photo |
|---|---|---|
| Seats/armrests | Both seats will not respond to air ride controls | |

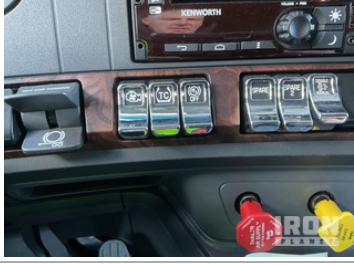
| Engine Brake | Not operationally checked | |

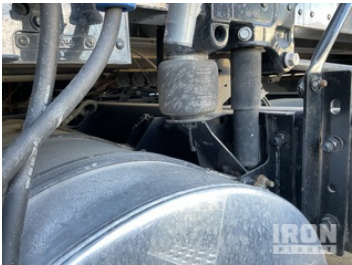
| Cab Suspension Air Bags | ★ ★ ★ ☆ | |

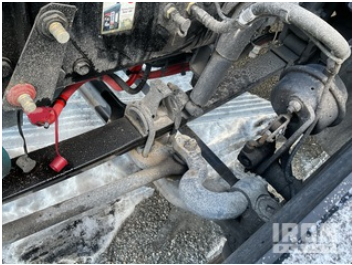
| Suspension Springs/Hangers | ★ ★ ★ ☆ | |

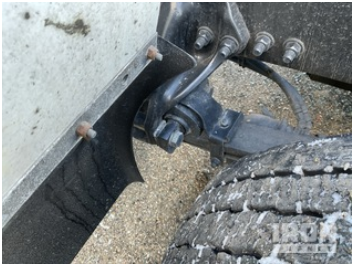
| Suspension Bushings | ★ ★ ★ ☆ | |

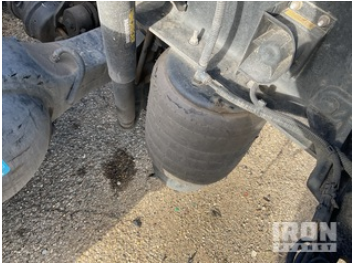
| Suspension Air Bags | ★ ★ ★ ☆ | |
